## GIS手法・InSAR変位量を用いた 2007年能登半島地震の地表変位の抽出

**Detecting the surficial displacements triggered  
by the 2007 Noto Peninsula Earthquake  
by the use of InSAR and GIS techniques**

Takashi SAITO, Yo FUKUSHIMA, Koji MATSUNAMI  
Disaster Prevention Research Institute, Kyoto Univ.

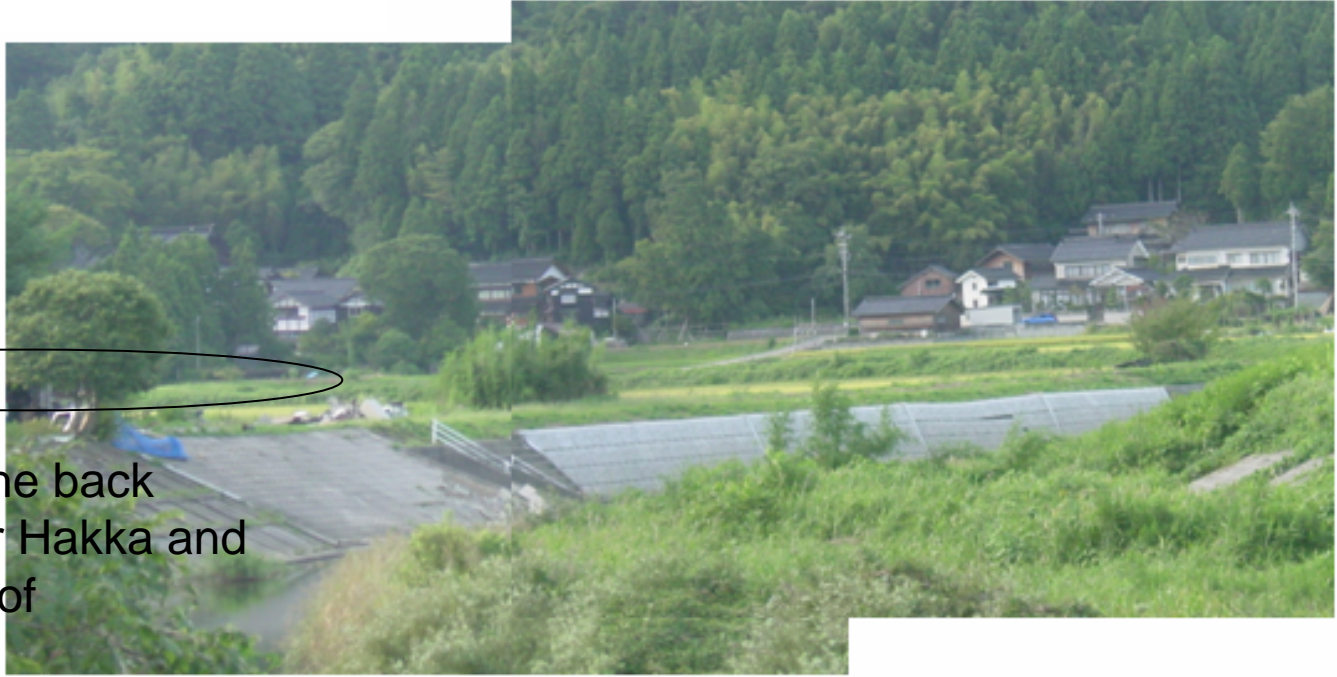
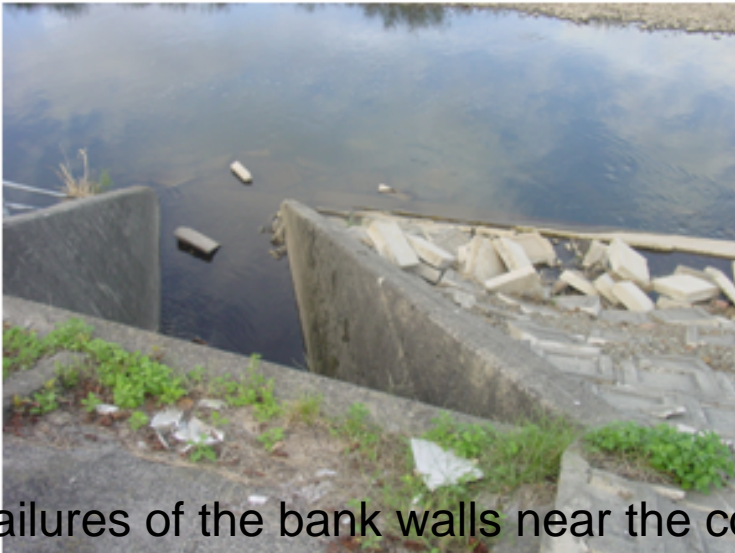
### M3: The failures of the banks of River Hakka

This area is the back lands of River Hakka and also the fans of substreams

The failures of the bank walls near the confluent point of substreams

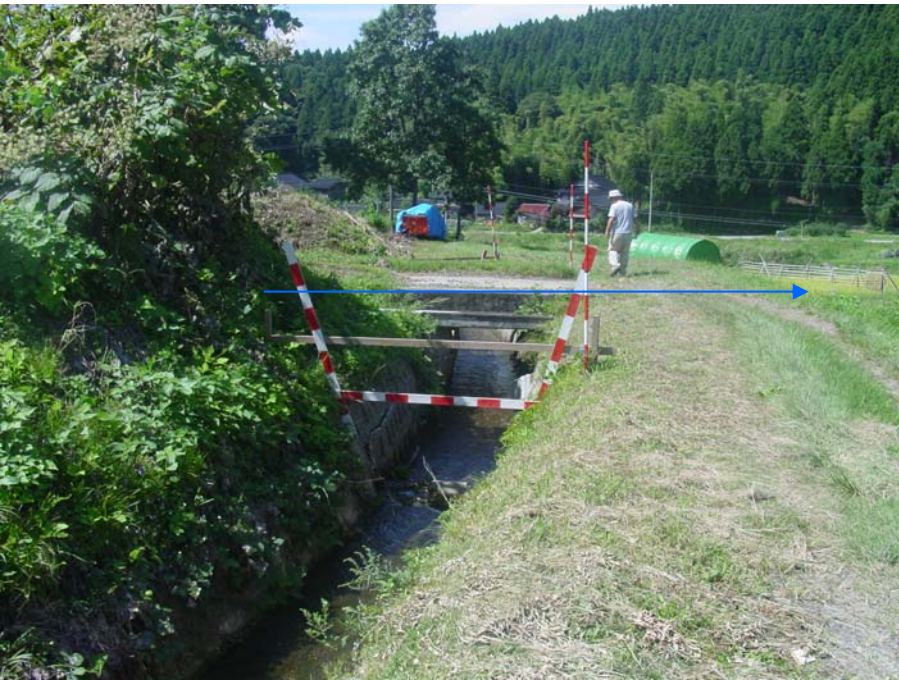
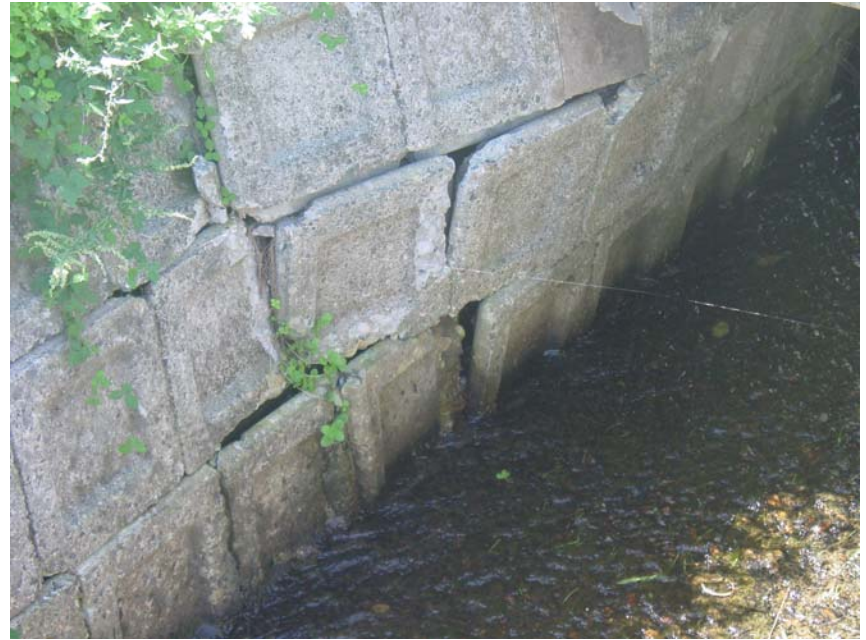
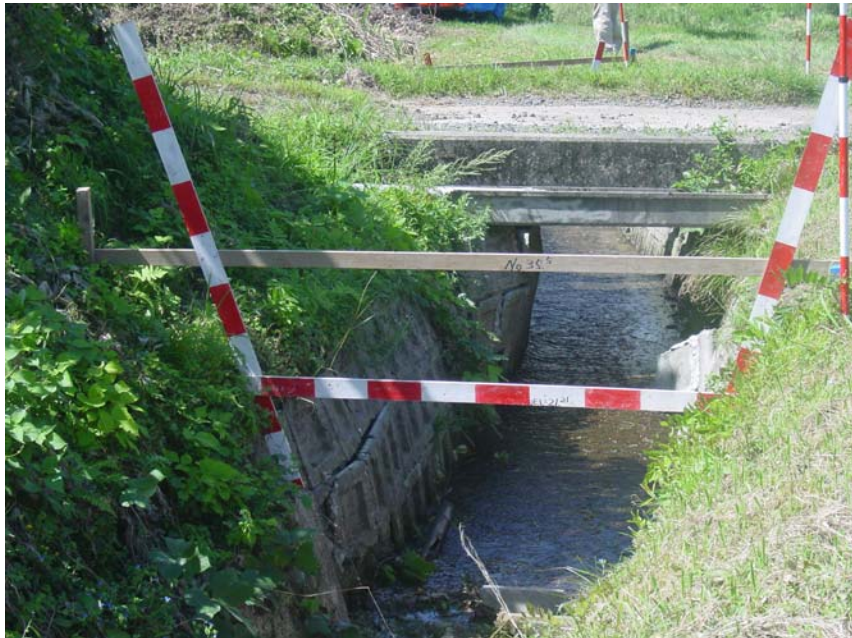
# The example of landslide in Ohkubo

The groundwater seepage were observed from the walls.

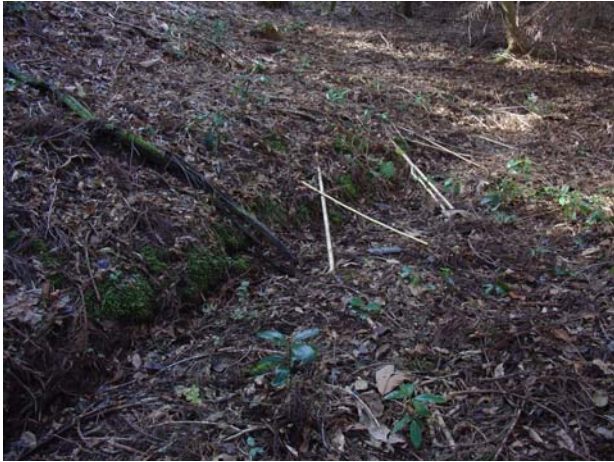
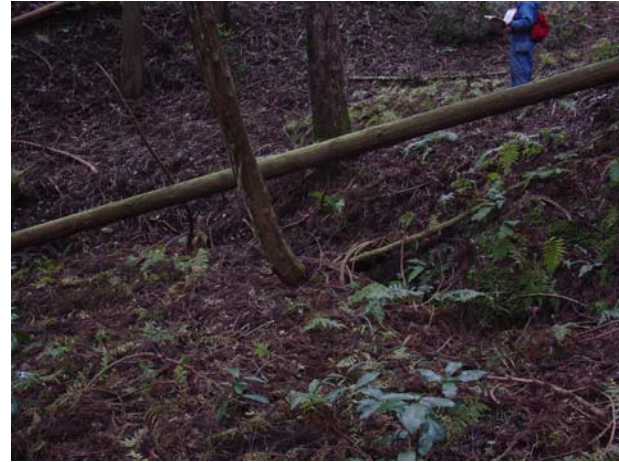
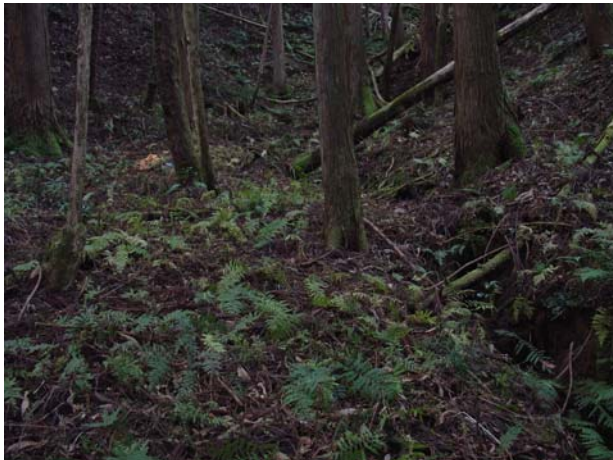
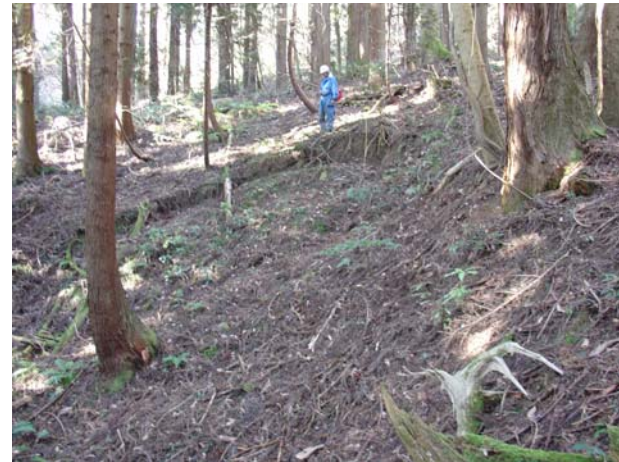
# Point A

The direction of the surficial movement is almost to the east.

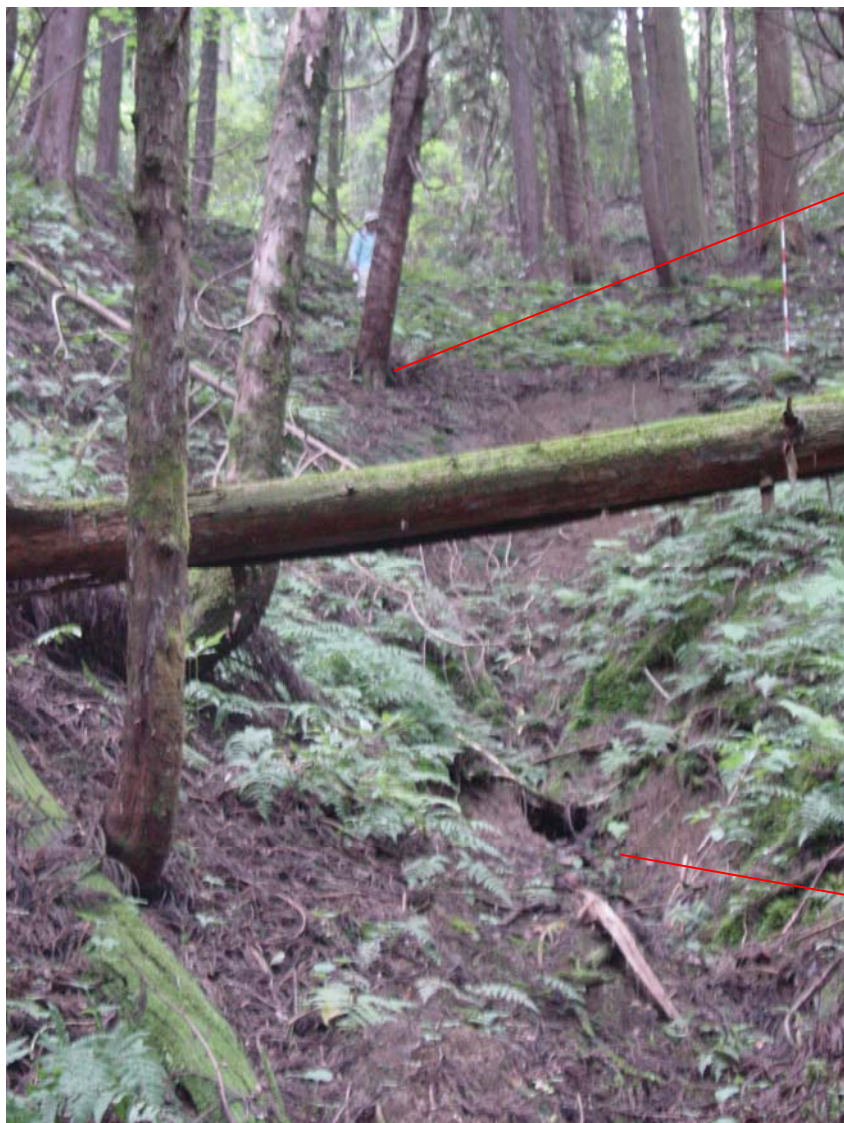
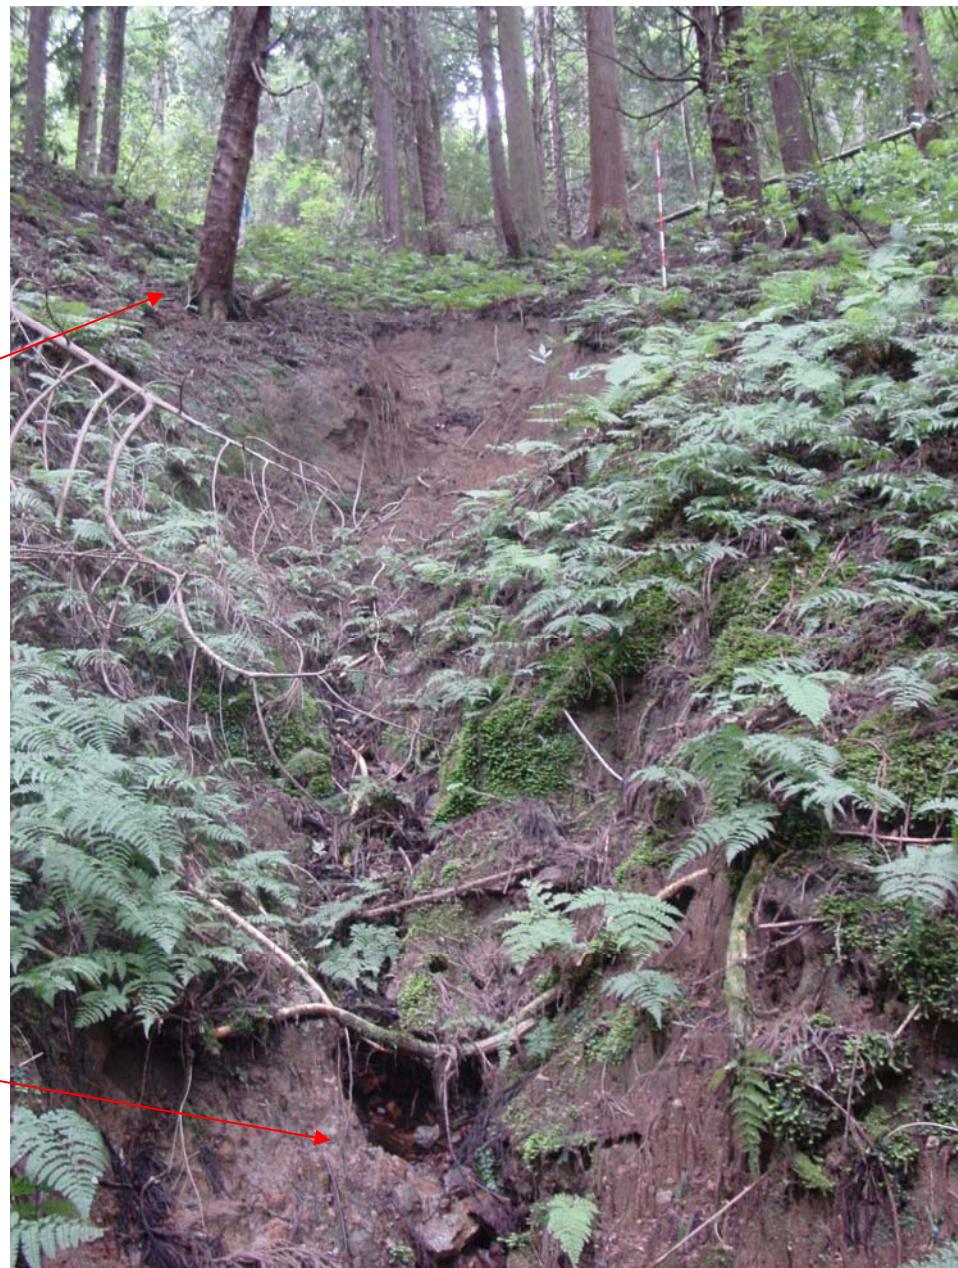
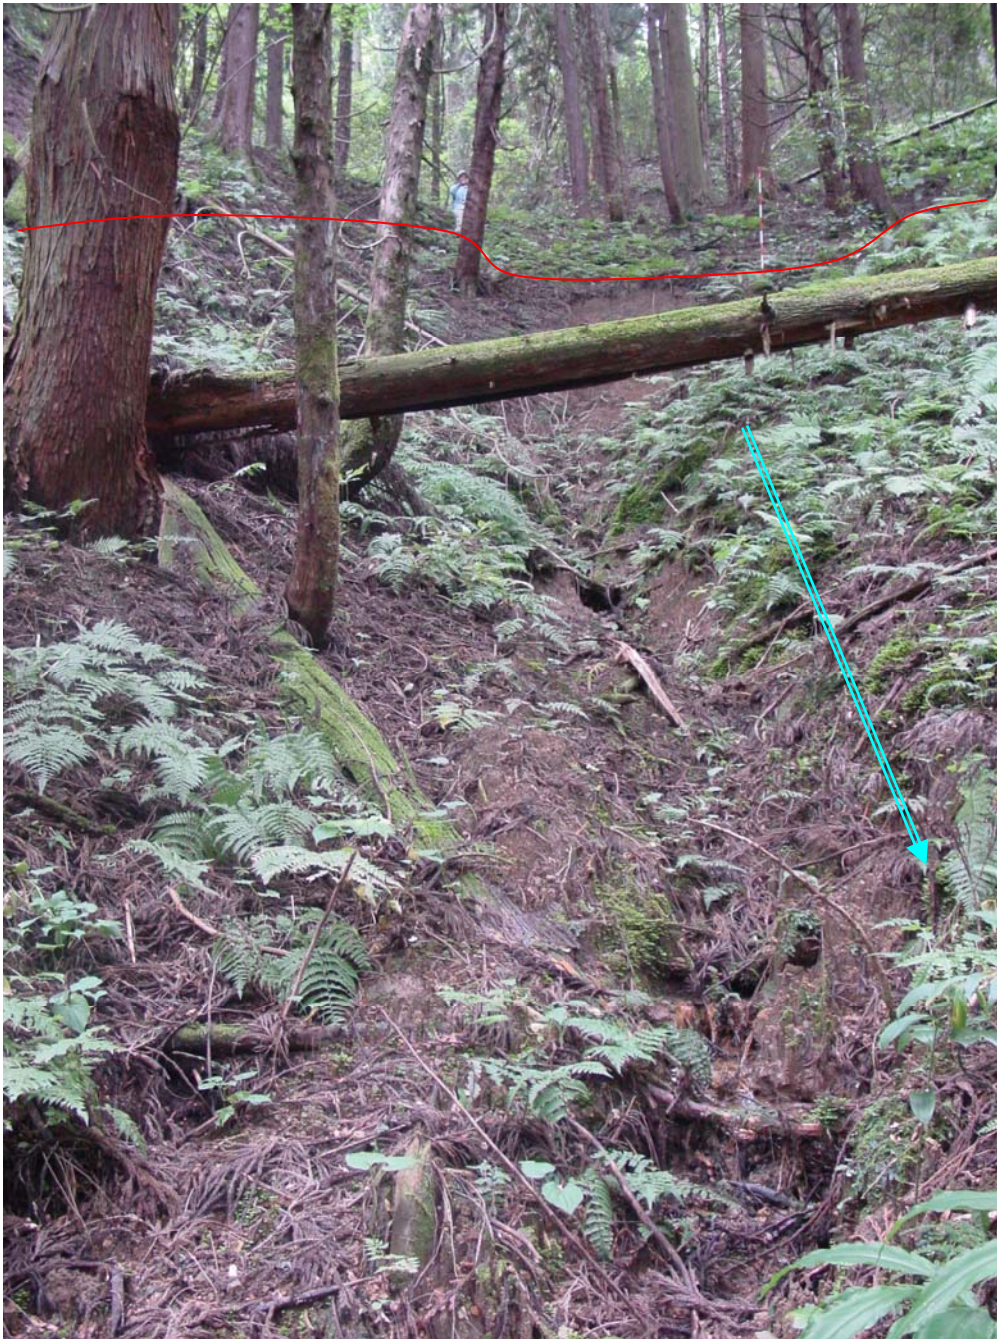
Ponit B

This slide could not be recognized in the result of InSAR of the ascending (Azimuth direction is  $N80^{\circ} E$ )

The light-blue arrow shows the direction of the slide. The direction is almost in north-east. The line shows the top of the scur.

In the result of InSAR of the descending (Azimuth direction is  $S10^{\circ} W$ ), this slide could be recognized as surficial displacements.
