SAR 干涉解析による地表変位と八ヶ川沿いの地形履歴の関係
(2007 年能登半島地震)

Relationship between the ground deformation detected by InSAR
and the geomorphic background along the river Hakka,
2007 Noto peninsula earthquake

齊藤隆志, 松波孝治, 福島洋
(京大防災研)

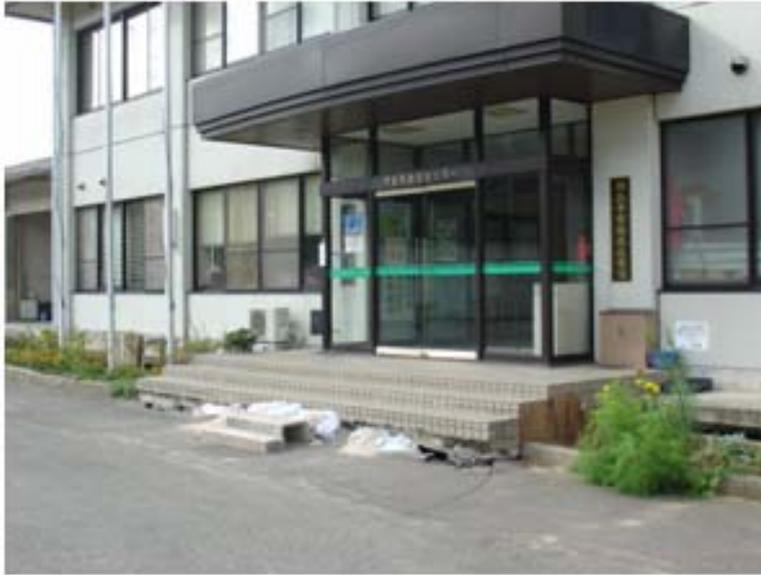
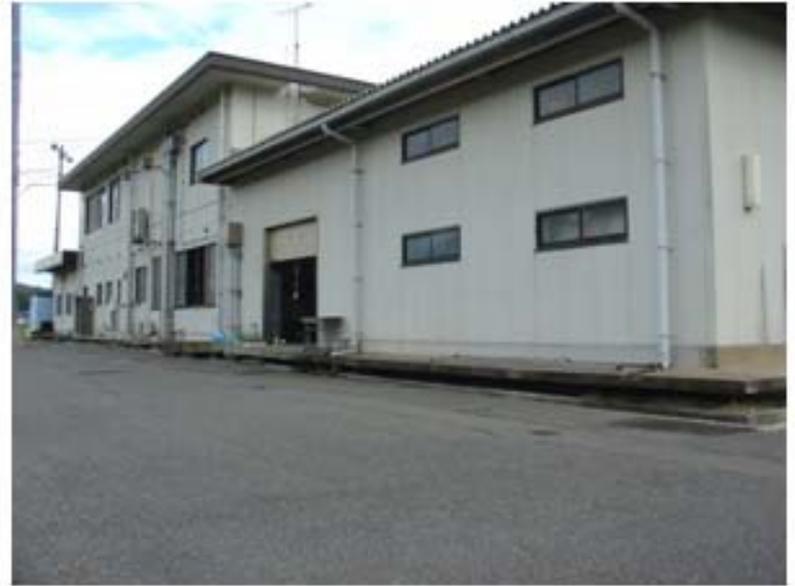
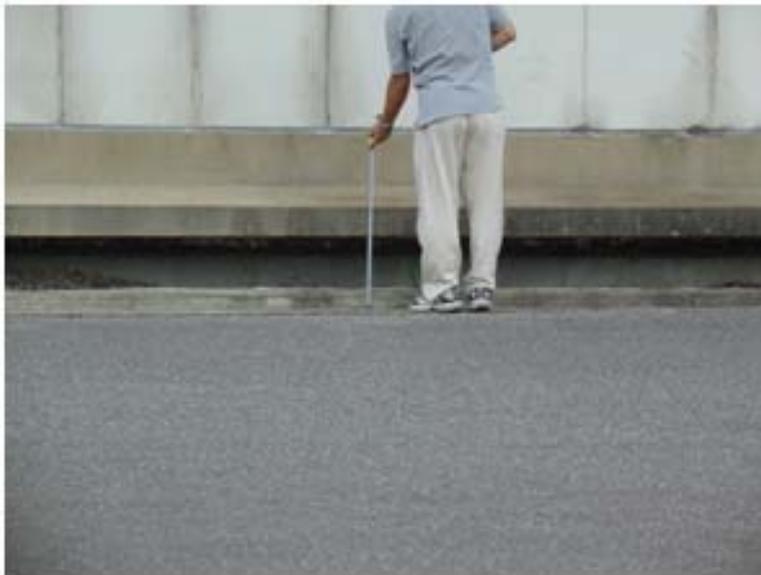
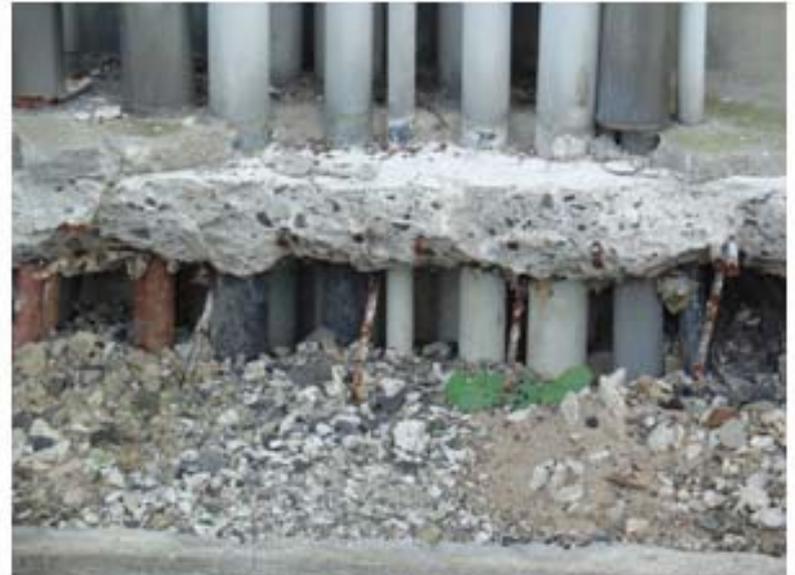
The ground subsidence at Monzen Bosai Center

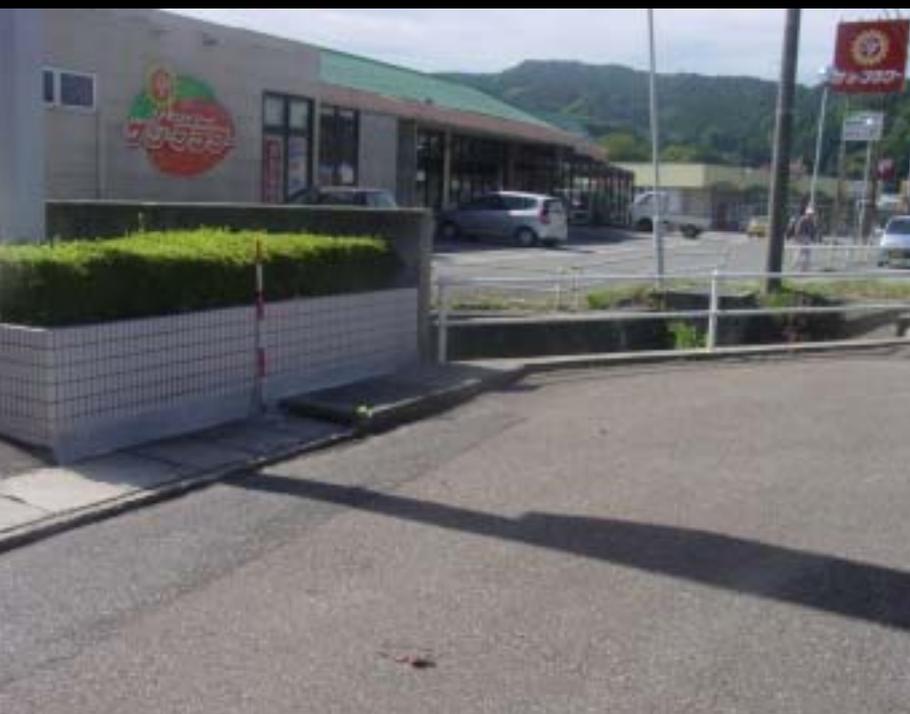
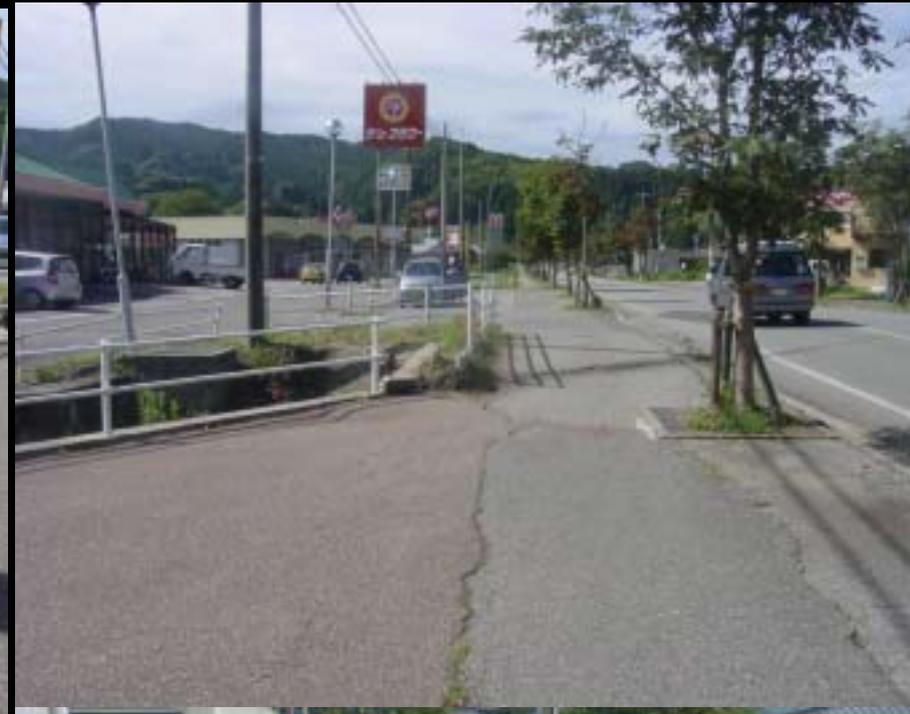
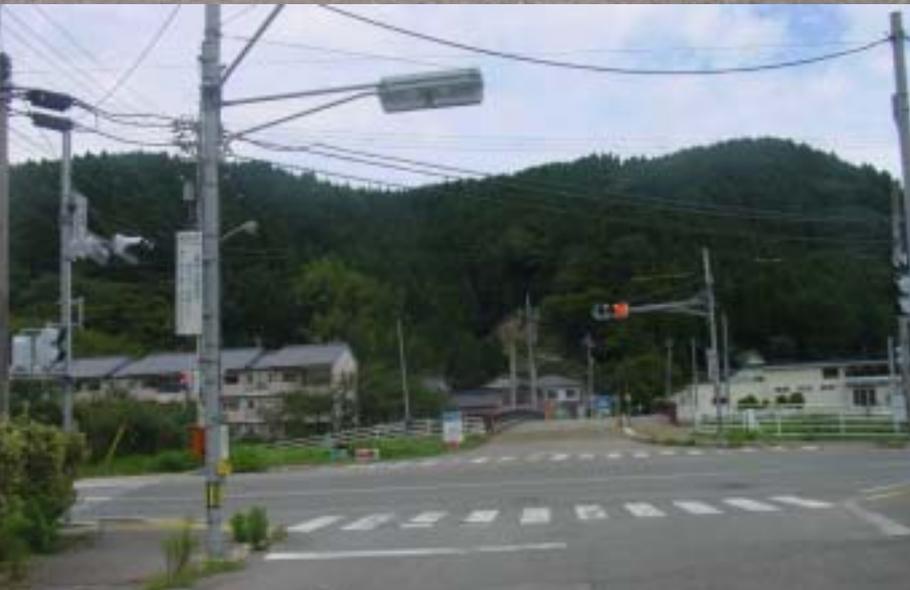
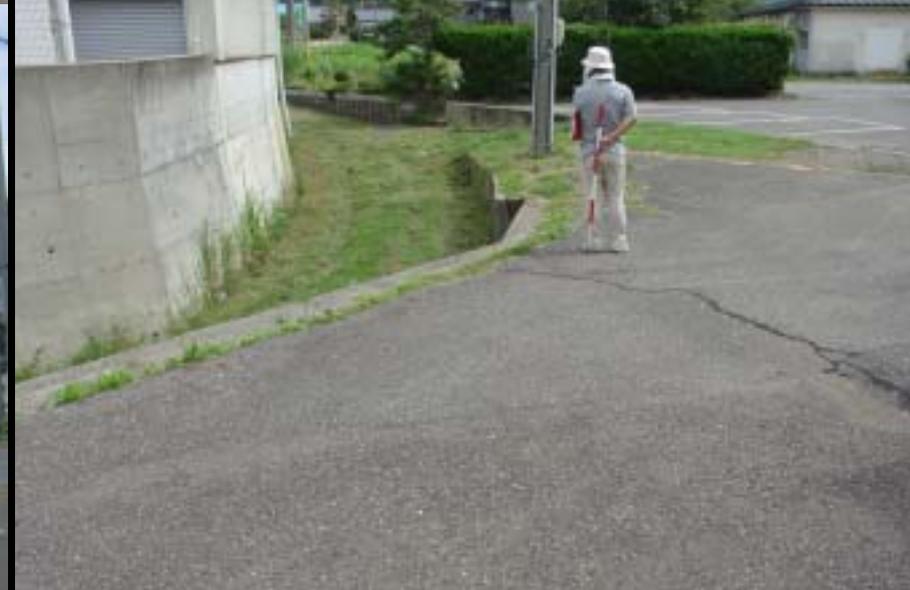
Ground subsidence near Hokkoku Bank: Hashiride

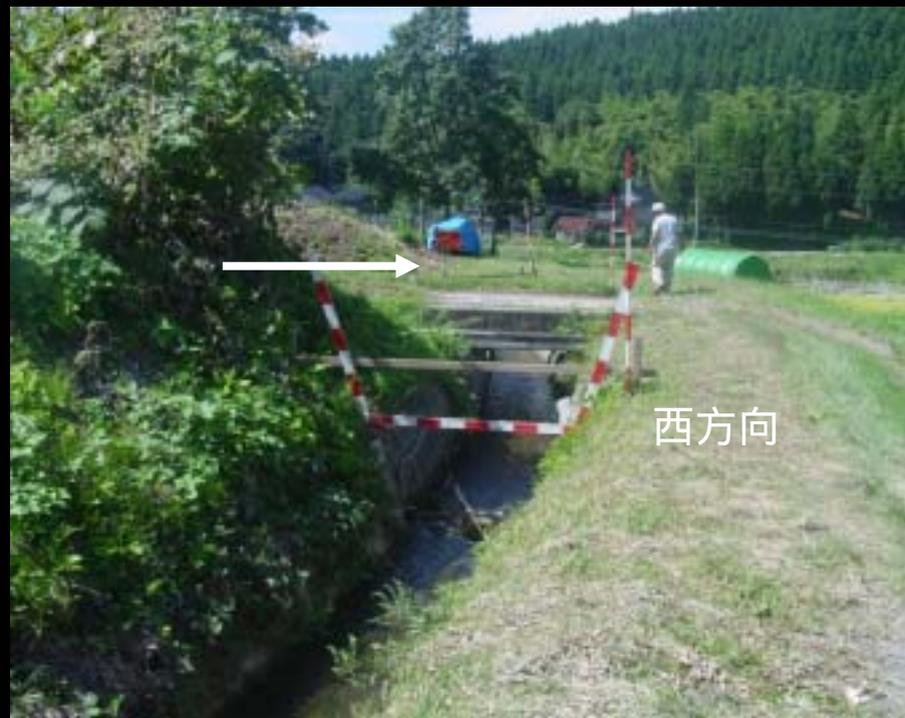
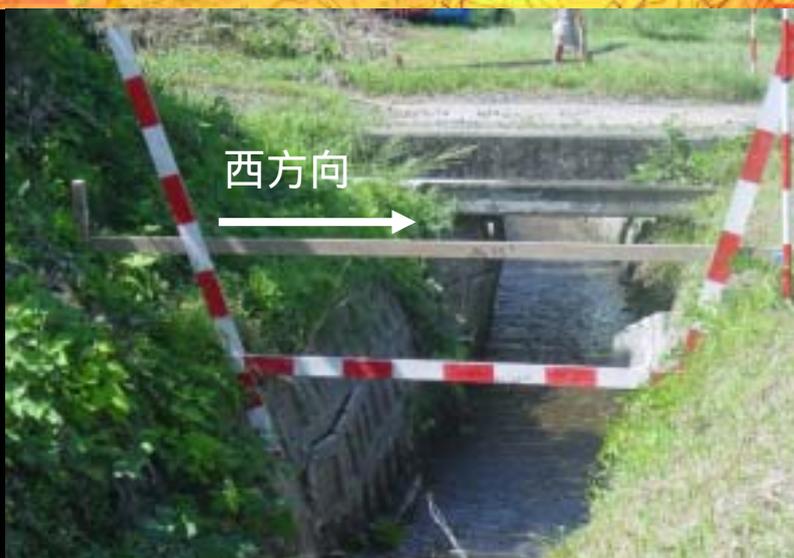
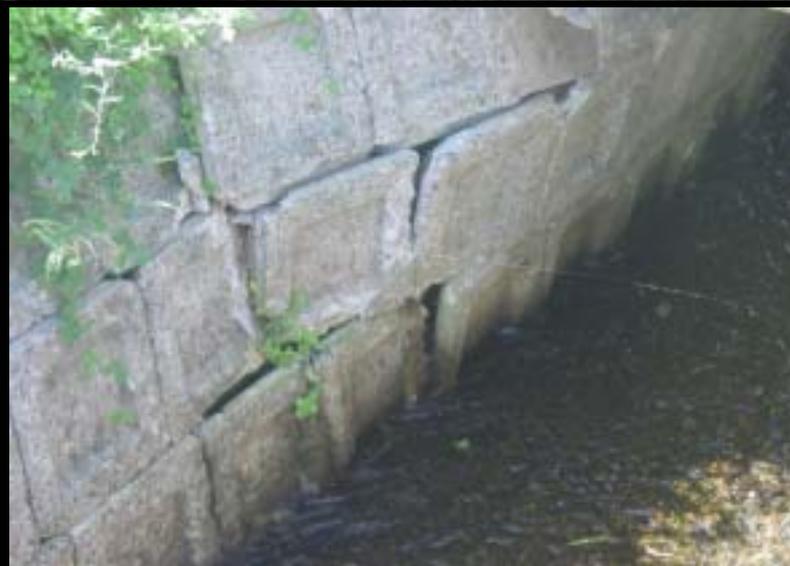
Landslide in Ohkubo

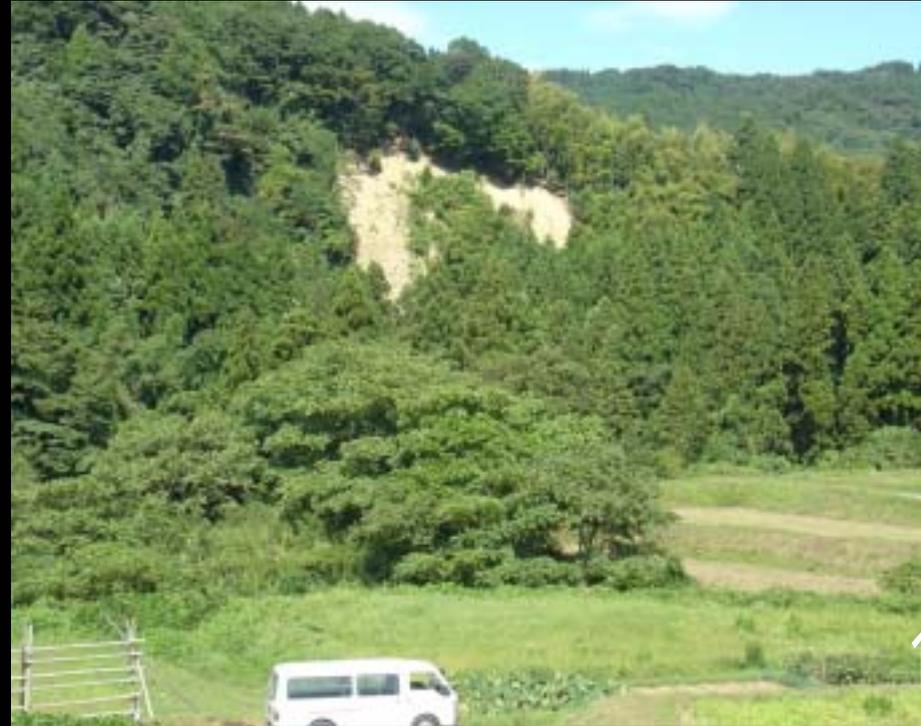
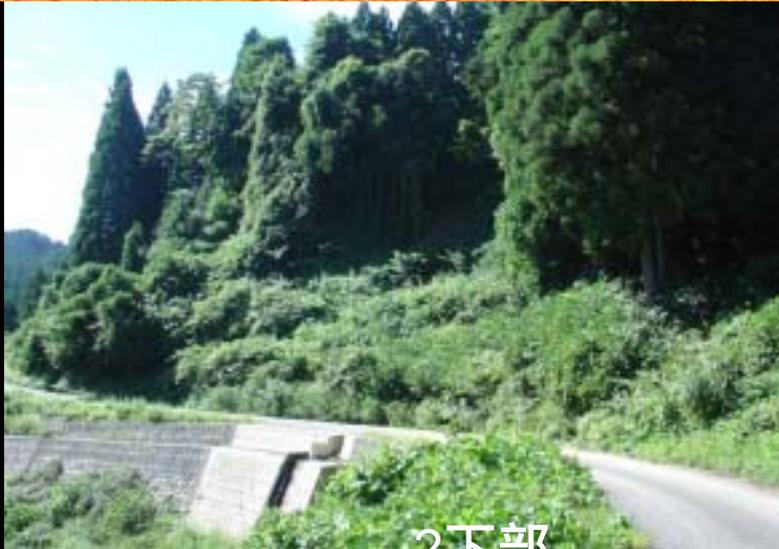
Slope failures at Asouda

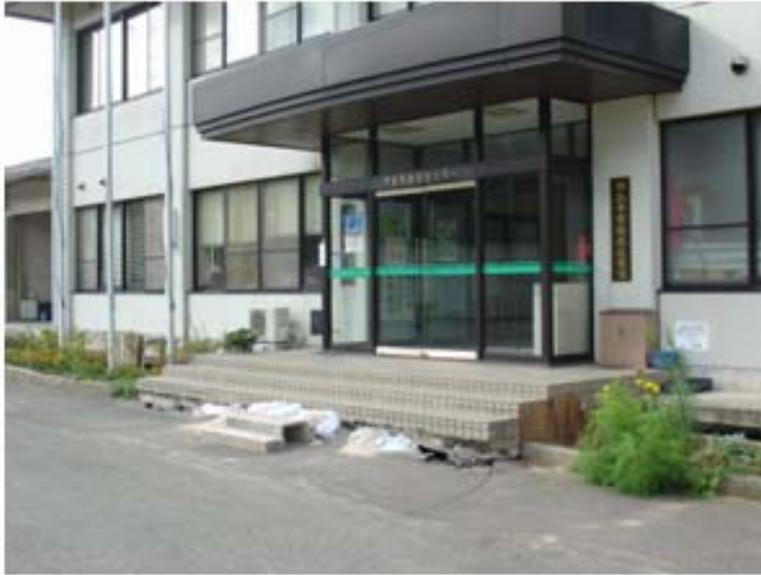
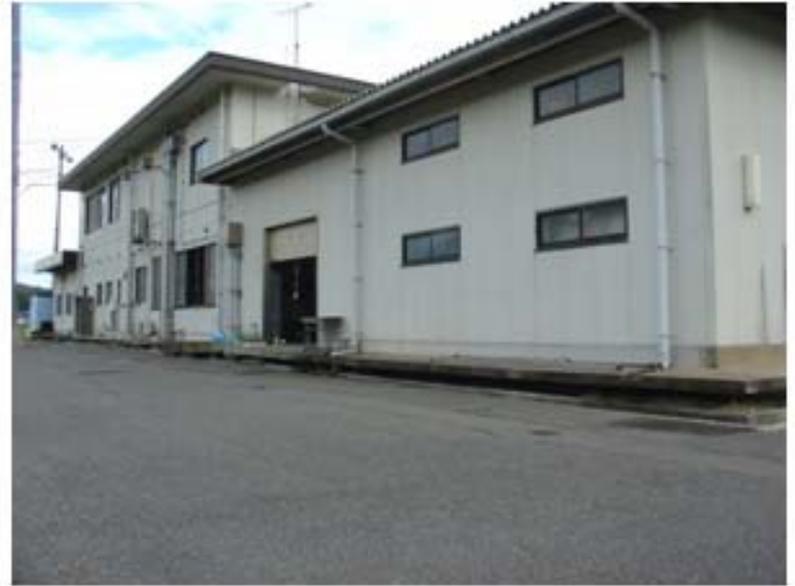
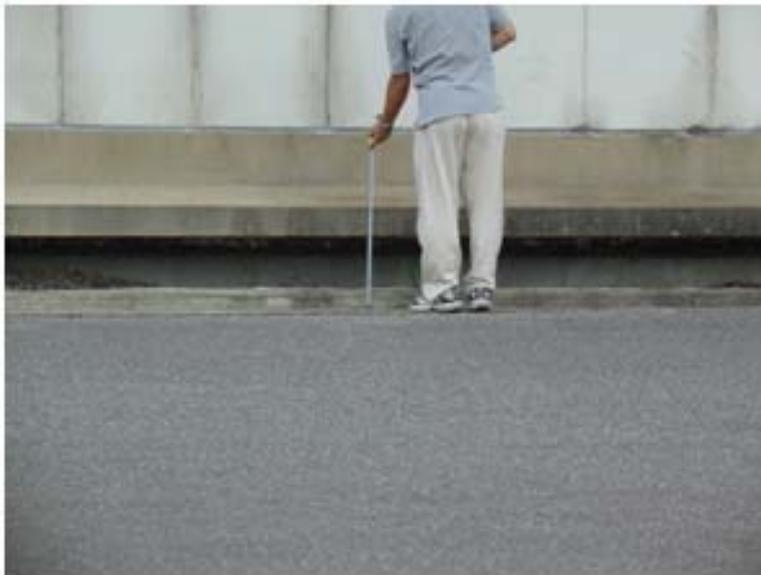
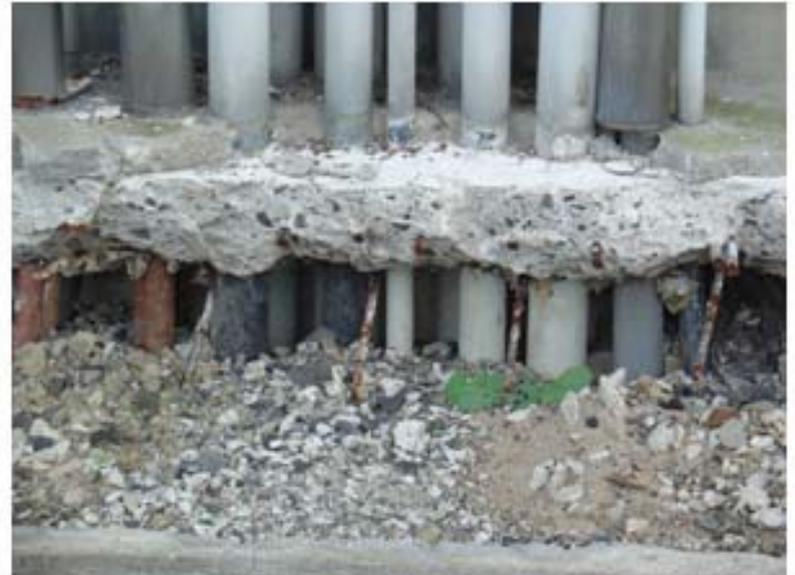
The ground subsidence at Monzen Bosai Center
